# FISH HEALTH INSPECTORATE VISIT REPORT

DATE OF VISIT 28/08/2020
SITE NAME Eilean Grianain
CASE NO 20200344

# **Escape Investigation**

The site was inspected following notification of an escape of 48,834 Atlantic salmon on 20<sup>th</sup> August 2020. (Marine Scotland escape incident number: MSe200820SAL1)

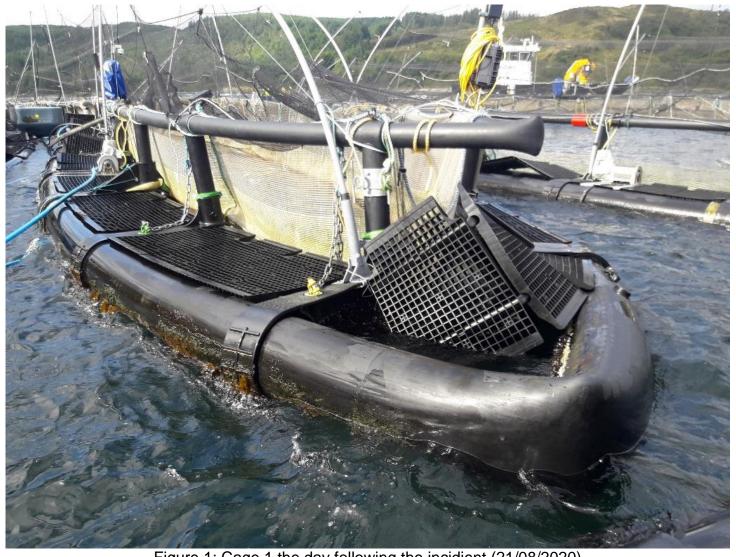
What caused holes is unknown on pen 1. Pens 4 had a buoy wash into it causing a hole. The deformation of pen 1 probably meant that the net had undue stress in places that it wasn't supposed to causing a hole to rip. However this is unconfirmed. Broken mooring ropes has been sent to Aberdeen for assessment. Multiple mooring lines snapped. Once one went that put more stress on other ropes causing a chain reaction, this is also unconfirmed. Unknown at present how many ropes snapped.

Figure 1: Cage 1 the day following the incidient (21/08/2020)

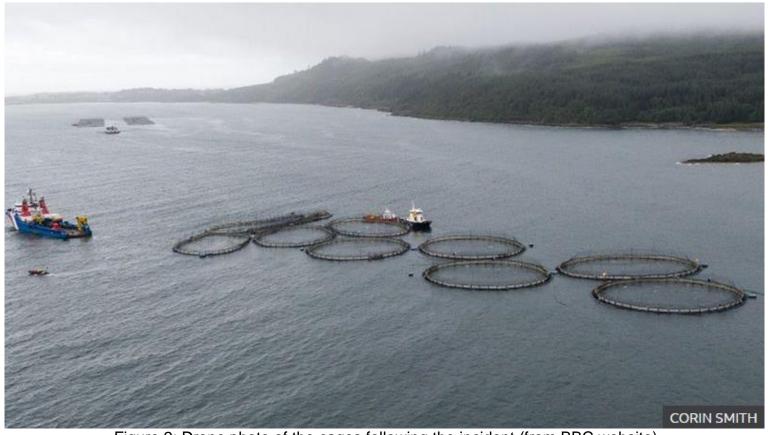
Figure 2: Drone photo of the cages following the incident (from BBC website)

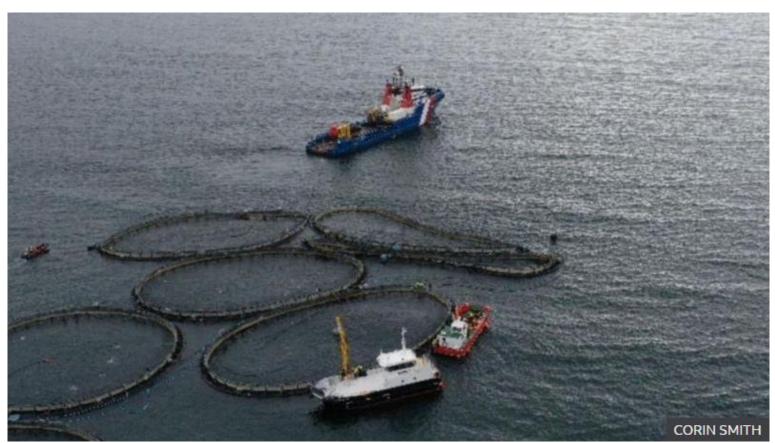
Figure 3: Drone photo of cages following the incident (from BBC website)

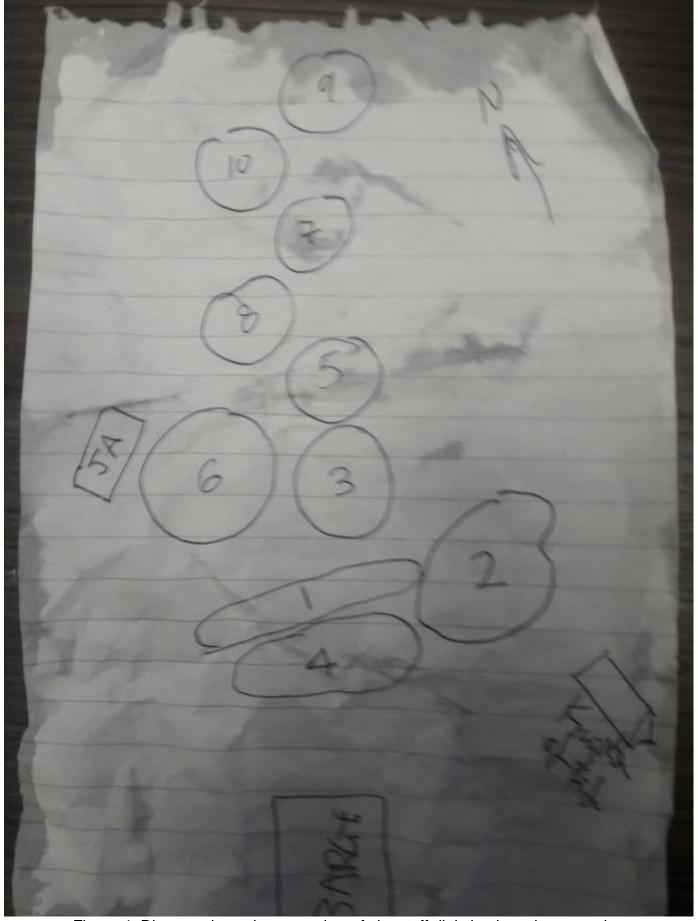
Cages moved approx. 200-300m.

Figure 4: Diagram drawn by a member of site staff dipicting how the cages lay following the incident
