# FISH HEALTH INSPECTORATE VISIT REPORT

DATE OF VISIT 28/08/2020
SITE NAME Eilean Grianain
CASE NO 20200344

# **Escape Investigation**

The site was inspected following notification of an escape of 48,834 Atlantic salmon on 20<sup>th</sup> August 2020. (Marine Scotland escape incident number: MSe200820SAL1)

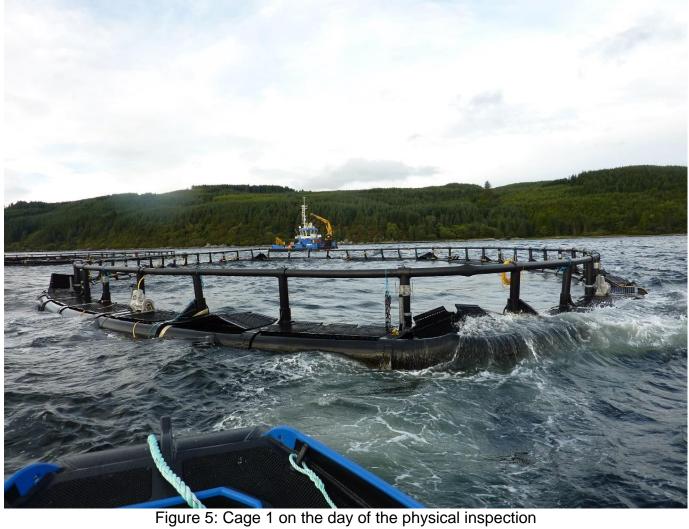
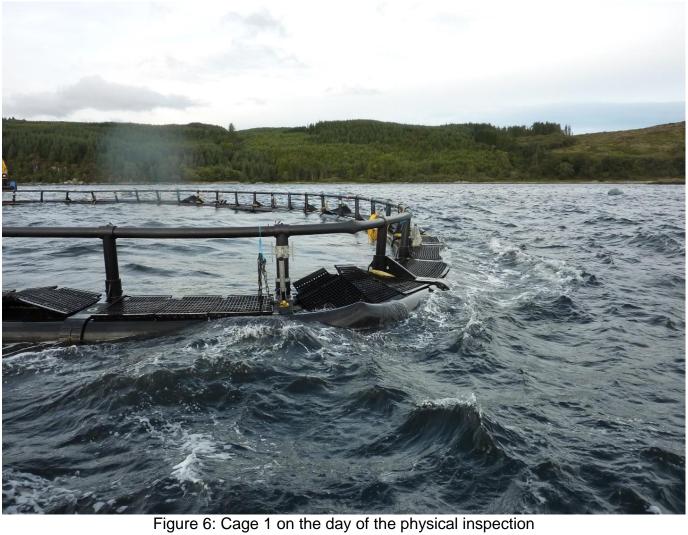
Last Thursday 10:00-10:30 call from site letting senior management know that the whole group of cages in the northern half of the site were moving north. Thursday the group was secured by a well boat and tug boat. 6 pens were intact, 4 were damaged (in the northern half of the site). Divers were in on Friday together with an ROV. Holes in pen 1 (which was written off) and 4 were detected. Four pens were harvested and morted (figures below)

Cages moved approx. 200-300m.

Figure 4: Diagram drawn by a member of site staff dipicting how the cages lay following the incident

It is recommended that Mowi Scotland Ltd. conduct a documented review of the procedures in place for the selection and installation of moorings in accordance with the Code of Good Practice for Scottish Finfish Aquaculture (CoGP) (Chapter 4, section 4.13). This should include a review of the selection of the anchor mooring points for the feed barge and the fish pens, and any possible interaction between mooring equipment over time.

It is also recommended that a documented review is undertaken of the standard operating procedure, risk assessment and inspection plan for the moorings on site in accordance with CoGP Chapter 4, section 4.16. This should include a review of the inspection method and frequency, for each mooring component, to ensure improvements to the re-installation procedures for the mooring equipment of both the pens and feed barge taking account of any possible interaction between the mooring equipment over time..
